1 Progress Report Summary

This project was to measure the fatigue performance of a decommissioned tidal turbine blade to help tidal stream developers reduce their uncertainty in blade design life. Understanding the loads and impact on blade structural performance is crucial in order to avoid premature failure and to increase confidence in tidal blade design, leading to reduced cost of energy. This project will model, define and apply these fatigue loads to develop a process for full-scale tidal blade testing.

7.2 Summary of structural test report on 5.25m tidal turbine blade

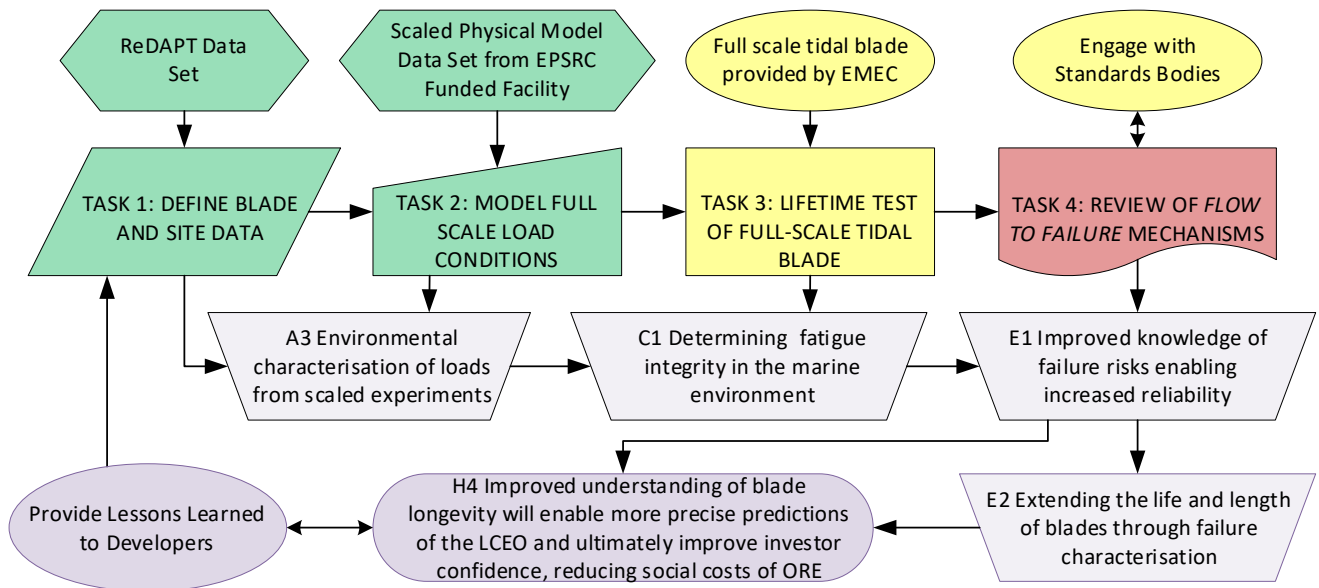
Figure 1: Overview of LoadTide project process indicating support. Red indicates incomplete, yellow is ongoing and green is complete.

This project combined state-of-the-art experimental facilities with leading numerical analysis to develop the pathways shown in Figure 1 that link ocean conditions to structural testing to determine blade fatigue performance. To do so, the project used existing metocean data, to study the transfer of wind load characterisation techniques to tidal scenarios, and trial new methods for test definition of full-scale tidal blade fatigue tests.

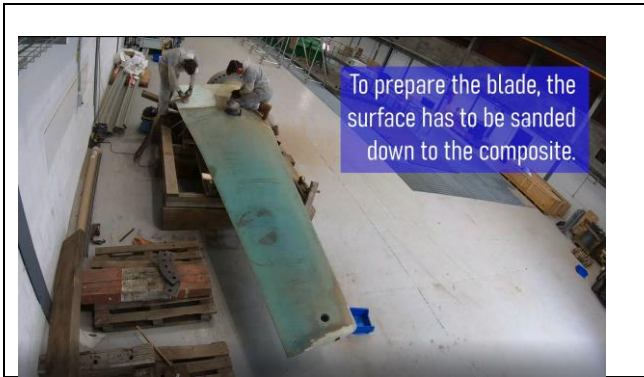
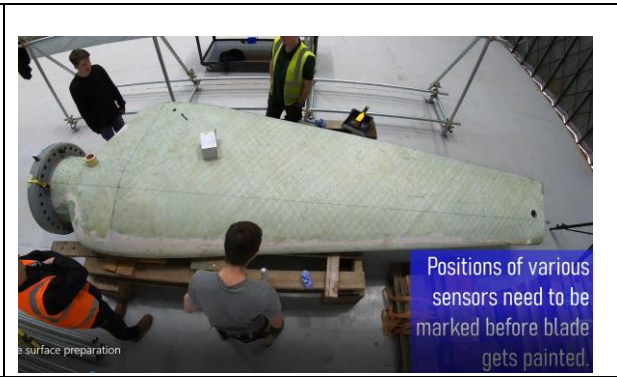
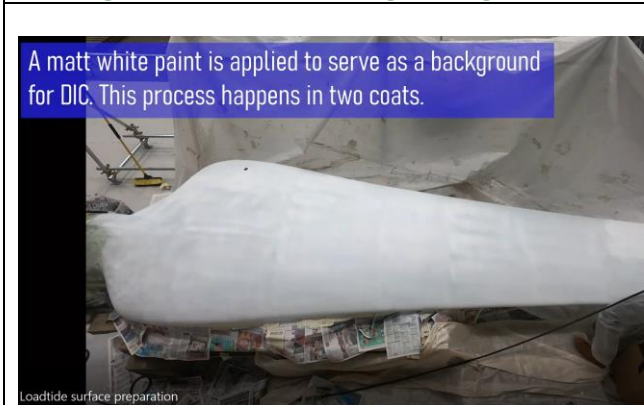
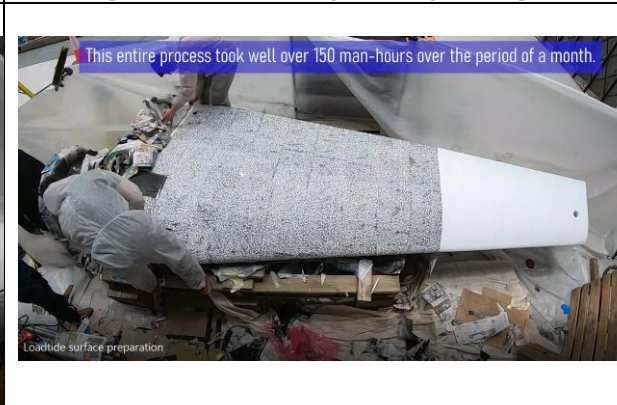
Figure 2 - Blade Surface Preparation for DIC

<p>Sanding off marine anti-fouling coating</p>	<p>Marking sensor locations prior to painting</p>

<p>Base coat of matt white</p>	<p>DIC speckle pattern over first 3.5m of blade</p>

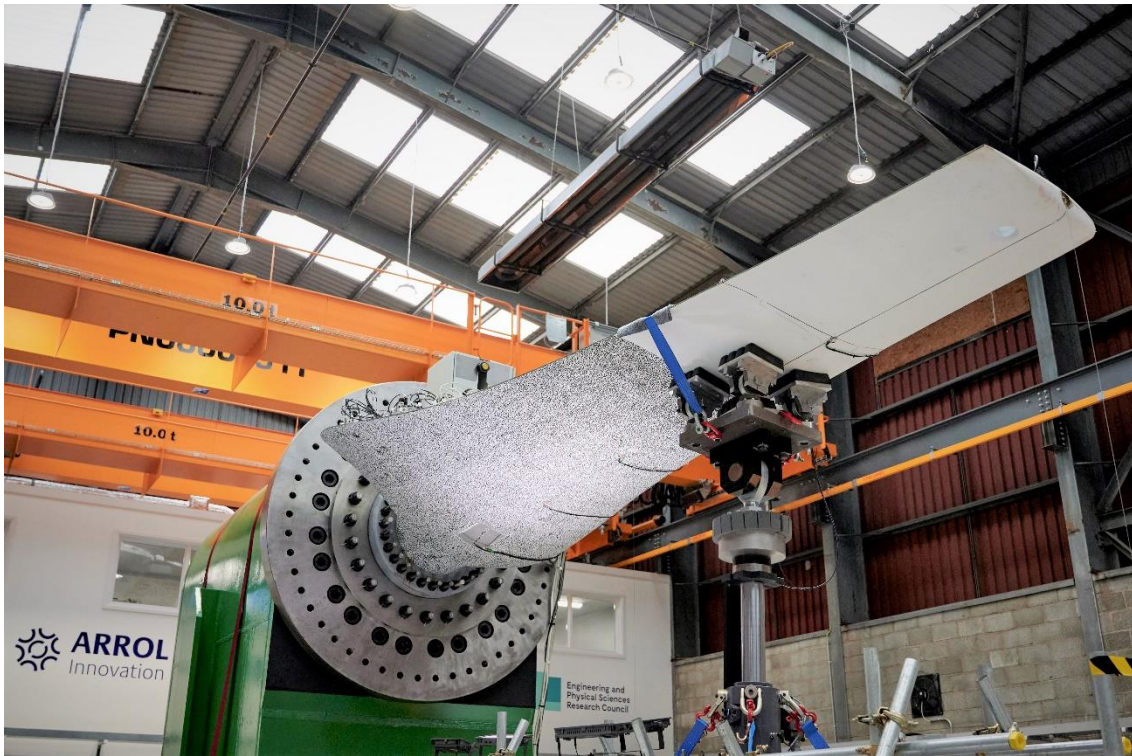
Figure 3 - Articulated Pad Saddle

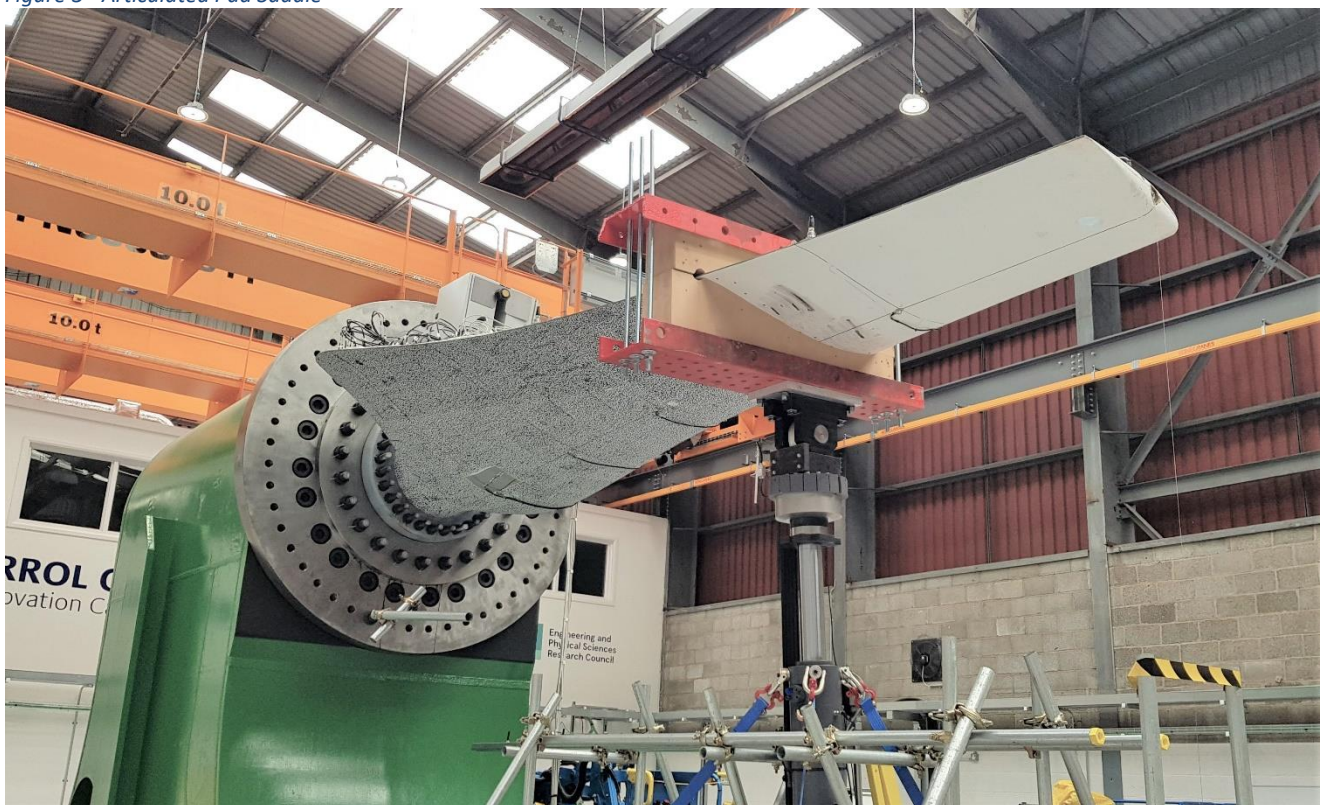
Figure 4 - MDF Clamp Saddle

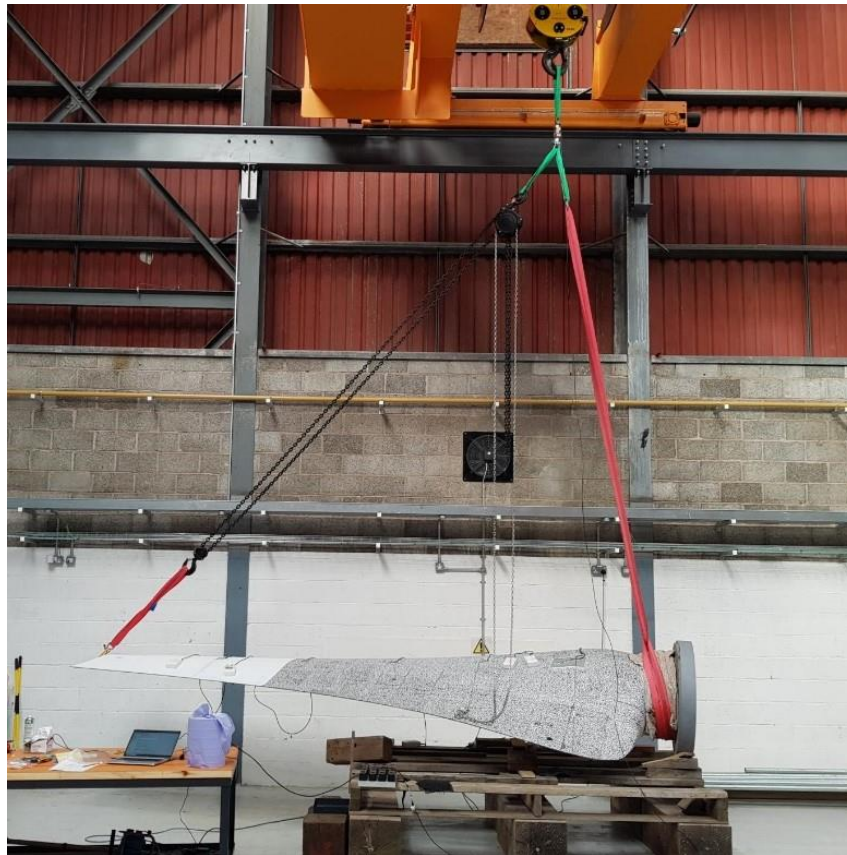
Figure 5 - Blade weight and centre of gravity measurements

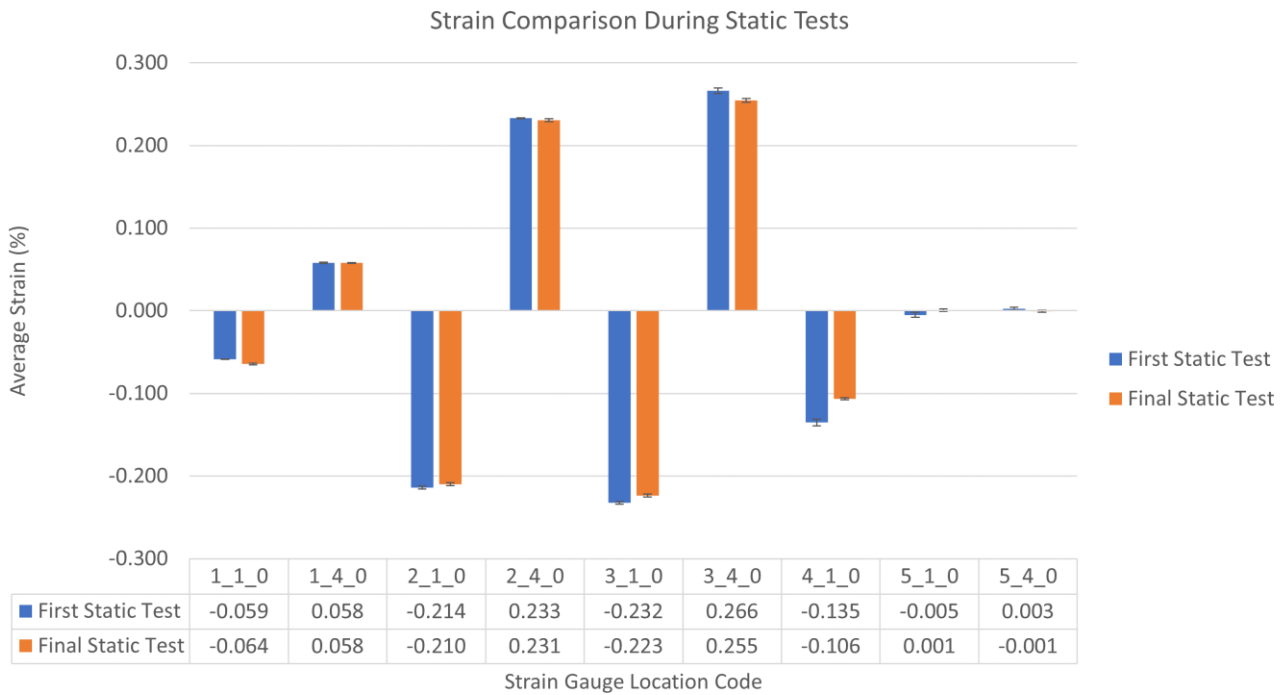
Figure 7 - Strain on top and bottom surfaces along blade length

The strain results from the static testing on the blade both before and after the fatigue testing are shown in Figure 7. In general, the strain has dropped at all measurement locations on the final static test. This indicates that it is unlikely any significant damage has been done to the blade as a result of the testing. Also, that the alterations to the test procedure as a result of changing the loading saddle (full description in attached report) have influenced the measured strain on the blade. As no other reason for a reduction in measured strain for the same applied load seemed plausible.

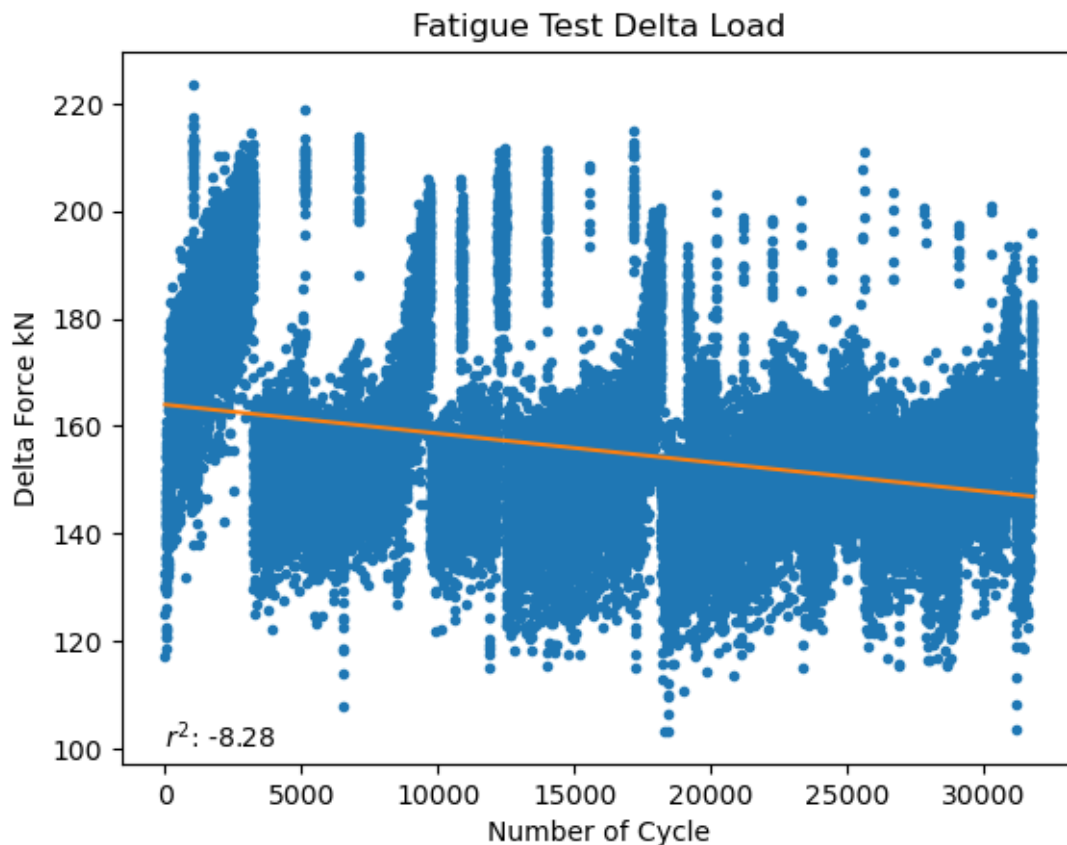
Figure 8 - Force delta during fatigue testing

The target load was 183.7 kN with an R ratio of 0.1, giving a target load delta of 165.34. Throughout the fatigue testing the delta load achieved was 155.46 kN with a resulting R ratio of 0.14. This deviation from the target was a result of the tuning of the FastBlade test system which is being commissioned as part of this test. The large spikes in delta load seen in Figure 8 are a side effect of the test starting and stopping during the tuning process
